PRODUCT: Cencon Gen2 Lock Firmware

BULLETIN: KABA Technical Services Bulletin #02

DATE: 09/22/2011, Revised 10/07/11

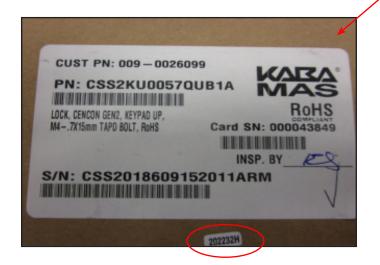
The unit boxes have labels applied.

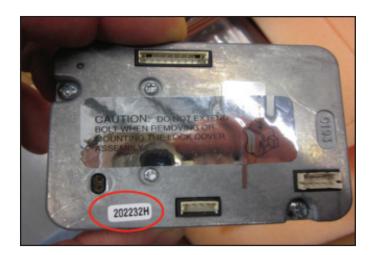
The lock body has label 202232H on case cover, which denotes the Gen2 firmware upgrade level to 2.0.929.
